# Worthenbury Conservation Area Assessment and Management Plan

*Adopted November 2009*

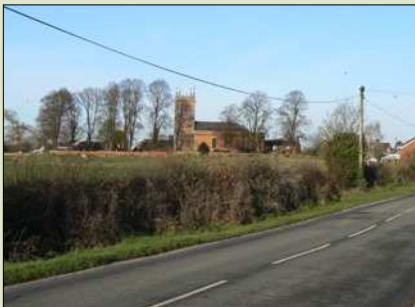
3.2 When approaching Worthenbury village, the tower of Saint Deiniol's Church dominates the skyline. It is set in an elevated position and is framed by a line of lime trees around the edge of the graveyard. The view of the church from Worthenbury Bridge is especially picturesque with the surrounding open fields adding to the pastoral scene.

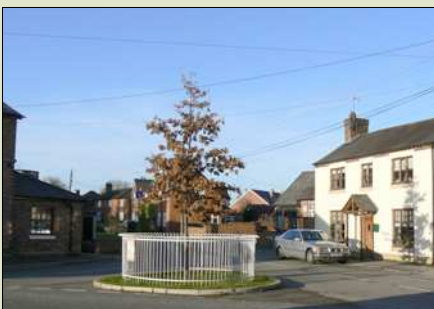
3.3 Another focal point in the village is the site of a once large oak tree with circular railings in the 'square', which is formed by a right-angled bend in the B5069 and the junction of Church Road. A new oak tree has been planted to replace the original tree.

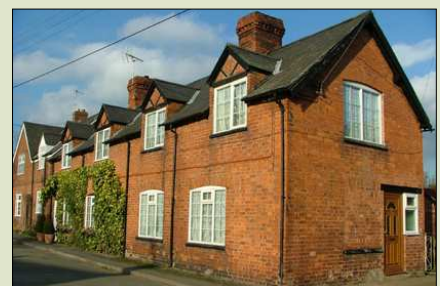
3.5 The strongest architectural theme is the Cheshire rural vernacular style. The cottages of 17th and early 18th century were originally built of timber frame with wattle and daub infill and thatch roofs. They were "modernised" in the 18th and 19th centuries with the

use of bricks for the infill panels and slate for the roofs. By the 18th century timber framing was abandoned and new cottages were built entirely of the local hand made brown/red brick. Originally single storeyed with attics, many cottages were raised to include a second floor in the 19th century, evidence of which can still be seen in the brickwork, some being in a slightly smoother red/orange brick. By this time it was possible to use building materials from slightly further afield with improvements in transport and road links.

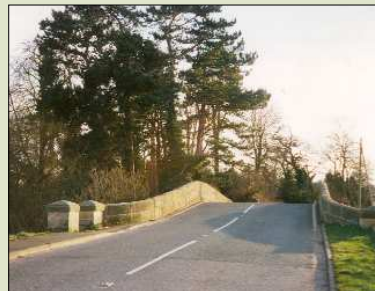
4.3 The road narrows and rises quite steeply as it approaches the humped-back, Grade II Listed Worthenbury Bridge. It was built in 1872-73 by the County Surveyor of Flintshire after the previous bridge was destroyed in floods. The parapets are constructed from large blocks of sandstone, probably re-used from the earlier bridge. The re-built single span arch is of a yellow brick of a type found elsewhere within the village. At the north end of the east parapet there is a set of sandstone steps leading down to the river bank where it is said the villagers would go to draw water. The bridge spans Worthenbury Brook, formed just a few metres upstream by the confluence of the Emral and Wych Brooks.

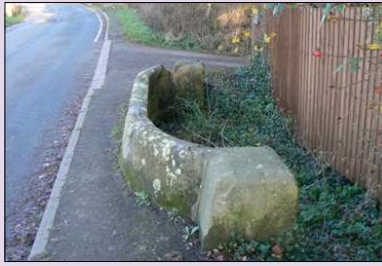
4.4 Just before the bridge on the right hand side of the road there is an historic low curved sandstone structure which is the headwall of a culvert running beneath the road.

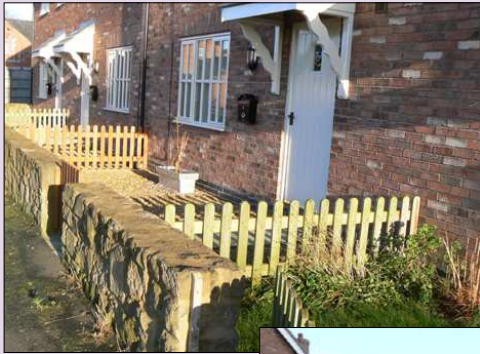
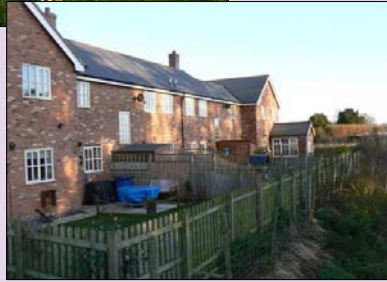
4.5 The Willows and White House Mews form a modern cul-de-sac development on the former site of White House Farmyard. The development maintains a strong street

frontage of terraced properties with relatively narrow plot widths characteristic of the village and

incorporates character features of the area such as a low stone boundary wall to the frontage and canopies over entrances. To the rear the cul-de-sac style development

with splayed entrance, footpaths, turning head and expansive areas of macadam and parking is much too urban

in design for the rural fringe. The rear garden areas display modern timber close boarded fencing, sheds and other garden paraphernalia on this important approach into the Conservation Area and detract from the visual quality of the area.

5.4 The removal or rebuilding of original or traditional boundary walling and hedges and their replacement with modern brick or fencing has had a detrimental impact on the character and appearance of the area. Modern timber fencing is particularly prominent to the gardens of Whitehouse Mews on the approach into the southern approach into the Conservation Area.

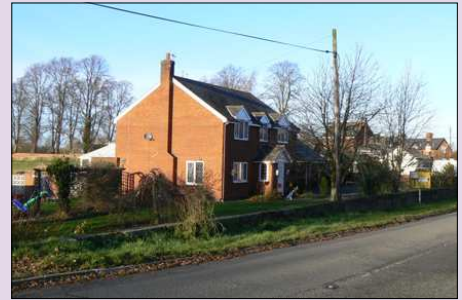
4.6 The view to the west from the bridge takes in the garden of Brooklea, which is a modern detached dwelling, set back from the road. In the garden on the bank of Emral Brook there is an impressive willow tree and an attractive low sandstone boundary wall to the front.

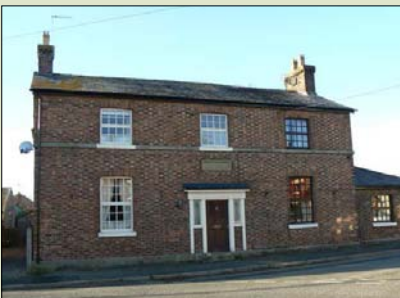
4.8 The early 19th century Plough Inn to the west of the junction has been converted to residential use and is particularly important to views of the square when approaching from the east. Its distinctive Flemish Bond brickwork

mirrors that of nearby Admiralty House. Its pillastered canopy doorway is prominent together with the name in relief in sandstone, stone string-course coinciding with the first storey window stone subcills - the centre one inscribed "1823", and gable end chimneys with decorative yellow clay pots. The original timber sash windows have been replaced with casements intended to mimic the original.

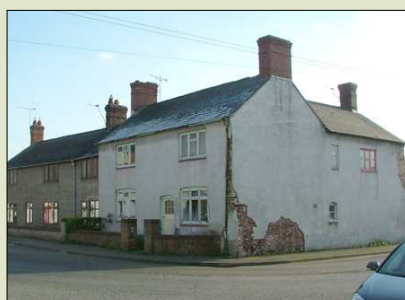
4.9 White House Farmhouse forms a terrace with Top House (a 17th Century timber-framed building), both fronting directly onto the village square. Both houses

have been cement rendered and modernised in the 20th century, sadly resulting in the loss of architectural detail. The wall to the front of both properties has been replaced with a modern brick wall. Between Top House and the Emral Arms, properties within Whitehouse Mews are highly visible and do not relate well to the historic street pattern in this area.

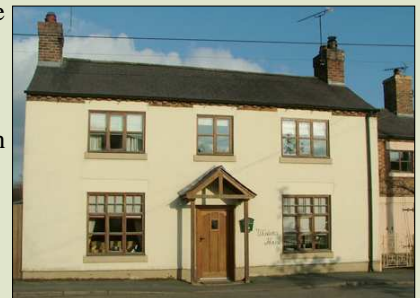
4.10 Wysteria House is in a particularly prominent position, terminating the view into the Conservation Area from the approach from the bridge. It is one in a row of distinctive buildings along the north east side of the square built directly onto the roadside. It has been modernised in the latter part of the 20th century with render and renewed dark stained windows. The sandstone cills and dentilled brick eaves, slate roof, and gable end chimney stacks however indicate its earlier date.

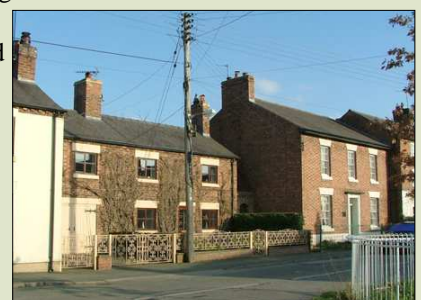
4.11 Wysteria Cottage is set back from the road behind a low brick wall with concrete copings and decorative 20th century railings above. The walling is of Flemish Bond brickwork in the local brown/red brick. The cottage

was extended to the west to create an arched under-carriage to the rear of the property.

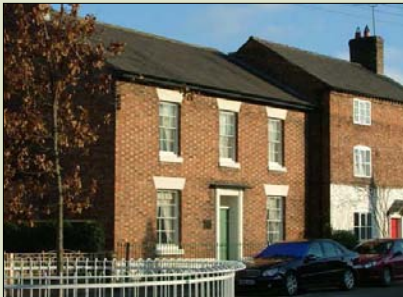
4.12 Admiralty House is a fine, Grade II Listed, late Georgian two storeyed building built in Flemish Bond brickwork. It has a symmetrical façade arranged around a central door with door-case and is separated from the road by railings with arrow-head finials, giving the building a superior aspect to its neighbours. There are five original twelve-paned wooden sash windows set in reveals with painted stone heads and cills.

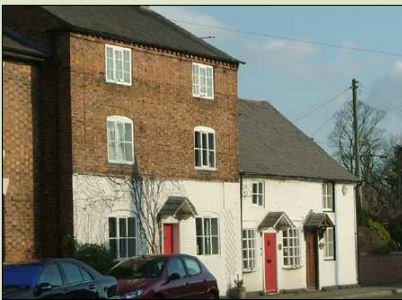
4.13 The Malt House is another attractive and distinctive Grade II Listed Building of three storeys in height. It is a late 18th to early 19th century building that incorporates an adjoining cottage to the east once used as the village Post Office. Originally two storeys, the ground floor has been whitewashed

and a third attic storey added later. Each level has two near flush windows; the ground and first floor being three light cast iron casements with glazing bars and central side hung

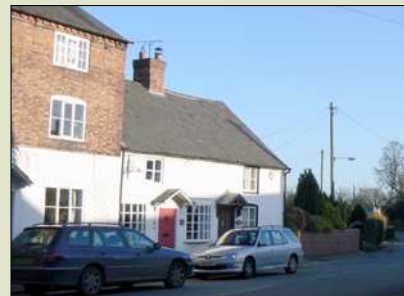
4.15 Mill or Shop Cottage was formerly used as a village shop. The cottage shares the same features as the adjoining

building. The front elevation has two near flush casement windows, with a low brick arch to the ground floor window and a similar arched window to the gable end. A bracketed porch has been added to the front.

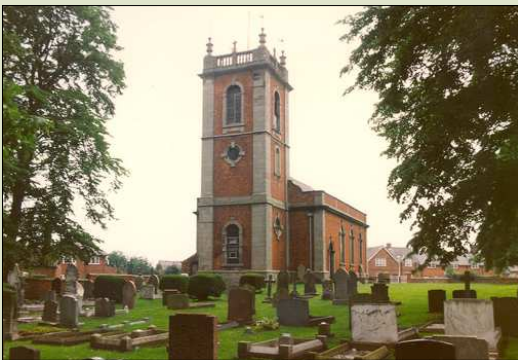
4.17 The church is built of red brick with sandstone dressings including a plinth, cornice and end pilasters with

a slate roof. It has a three stage square tower to the west-end and a semi-circular apse to

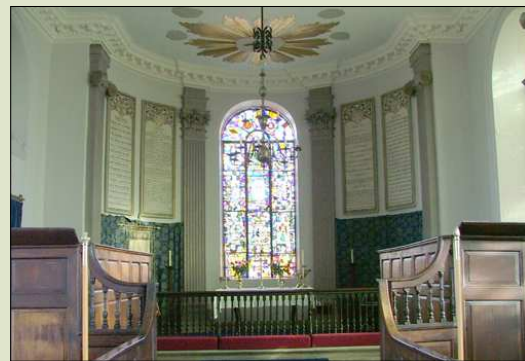
4.18 The captivating interior exhibits a complete set of box

pews, some retaining family crests and brass name plates on their doors. The coved plaster

ceiling has Rococo decoration and an enriched cornice to the chancel. There are four stained glass windows, the east window is said to contain medieval fragments and was bequeathed to the church by Lady Emma Elizabeth Puleston when the chapel at Emral Hall was demolished in 1775. The oak cross from this chapel has also been retained, being brought to the church after Emral Hall was demolished. Ornate brass chandeliers and an old oak chest made for the safe-keeping of the Church Plate and money are other attractive and historical features. The church contains many monuments to wealthy landowners, the Puleston family being especially well represented.

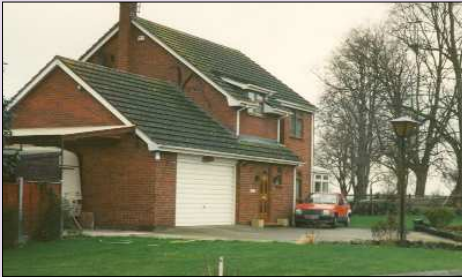
4.20 On the opposite side of the road stands Covington, a modern house with brick walls and concrete tile roof. It is set back in its plot behind open gardens and the front

boundary which is a mix of a low weathered sandstone wall and a red brick wall with blue ridge tile copings.

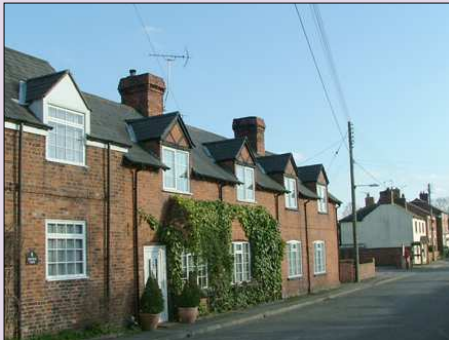
4.21 Numbers 1 and 2 Rose Cottages and Church View make an attractive terrace opposite the church. They were most likely built as farm-workers cottages. Fronting directly onto the roadside and built of Flemish bond brickwork, 1 and 2 Rose Cottages have four half-timbered dormer windows with brick nogging. Ground floor windows have cambered brick arches and there are timber cills throughout. There is a slate roof and massive central brick chimneys.

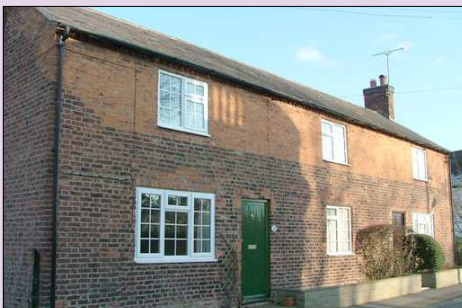
4.22 School House and Church House form a semi-detached pair of early 19th century cottages. At first floor level the change in brick colour indicates where the roof was raised, probably in the late 19th century to create bedrooms. School House was once used as an ale house

called The Butchers Arms. Church House has retained some cobbling to its frontage. Attractive brick built outbuildings to the rear of

Church House were once used as a pigsty, stables, shippon and slaughter house (now demolished), belaying its history in the 19th century as an abattoir and butchers shop.

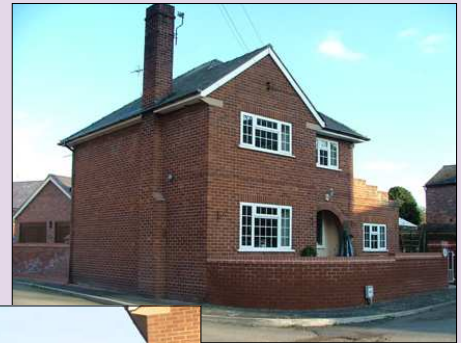
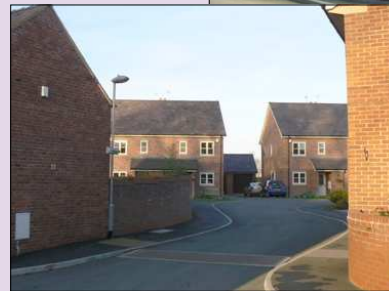
4.23 Dawsons Farm house has a distinctive 1950's/60's design with a hipped roof, arched entrance doorway and

stepped gable to the garage. To the north west of the house is the former farm-yard, now Dawsons Farm Mews, a modern cul-de-sac development. The roadside barn, now converted into a dwelling is the only remaining historic structure on the site and

probably dates to the late 19th century. Once again, the splayed entrance, pavements with concrete kerbs and wide areas of black macadam are overly

suburban in appearance and detract from the rural character.

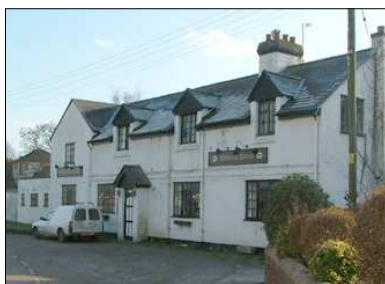
4.27 Set just before the junction of the B5069 with Mulsford lane, the Worthenbury Arms, (previously the Emral Arms) dominates the street scene. This 19th century building has been extensively remodelled and rendered in the latter part of the 20th century so that few original historic

details are visible. The roadside elevation has three dormer windows to the first floor, the left window being an original Yorkshire horizontal sliding sash. The building is now only partially used and it and its frontage requires general maintenance.

ENHANCEMENT PROPOSALS	RESPONSIBLE BODY
Emral Arms - The appropriate upkeep of this prominent building and its curtilage within the centre of the village is essential. A suitable scheme for landscaping and re-surfacing for both the car park and building frontage would greatly enhance the appearance of the property and Conservation Area generally.	Private landowner

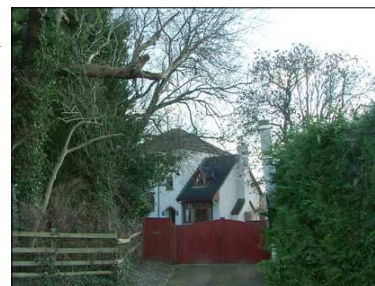
boundary but adversely affect its setting. Straight ahead is Mulsford Lane, a narrow grass verged country lane leading to The Old Rectory and Bowling Bank Farm.

The field boundary to Frog Lane has a mature hedgerow. Unfortunately a modern wire fence has replaced the boundary to Mulsford Lane. There are far-reaching views to fields and hills to the north across this open field.

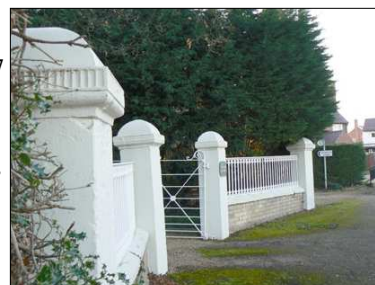
4.31 The entrance to the Grade II Listed Old Rectory is via a gateway with substantial stone piers and attractive cast iron railings on top of a yellow brick wall with sandstone copings. The house is set in its own grounds, with tall mature specimen trees and a gravel driveway. Originally built in 1657 by Judge Puleston of Emral Hall for the Reverend Philip Henry, it was enlarged in the Tudor Gothic style in 1833, retaining

elements of the earlier building. The substantial three storey building has painted render walling with a slate roof behind a parapet and five tall paired, yellow-brick chimney stacks with decorative pots. There are three parapeted gables, a string course at first floor level and projecting hood-moulds to the window openings. There is a two-storey entrance porch with a 4-centred arch opening.

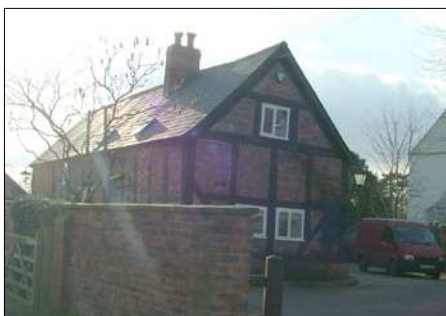
4.32 As the name suggests, Stable Cottage was formerly the stables to The Old Rectory. To the front there is an historic curving brick wall and gate piers with sandstone copings, which mark the second entrance to the Rectory. The cottage is one of the oldest buildings in the village being probably early 17th century and,

although not listed, is an excellent example of a timber box frame with brick nogging infill panels. The steep pitched slate roof would originally have been thatch, the central brick chimney being a later addition on conversion to a dwelling. The cobbled edging to the curtilage is reminiscent of its origins as a stable block and makes an attractive setting.

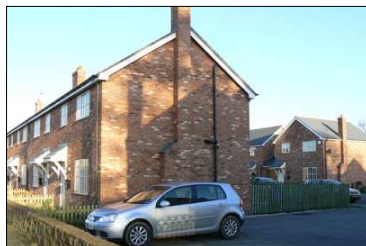
5.2 Modern cul-de-sac housing developments on the boundary of the conservation area adjacent Worthenbury bridge and on Church Road are very suburban in character and appearance and do not reflect the informal linear layout of the rural village.

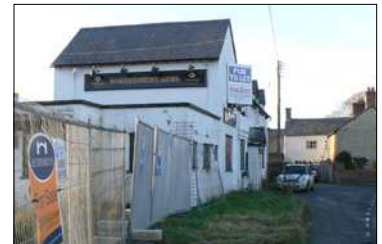
5.5 The closure and subsequent lack of maintenance of the Emral Arms is a cause for concern both in terms of the detriment to the visual quality of the area and the loss of vitality resulting from the closure of a public facility in the heart of the village.

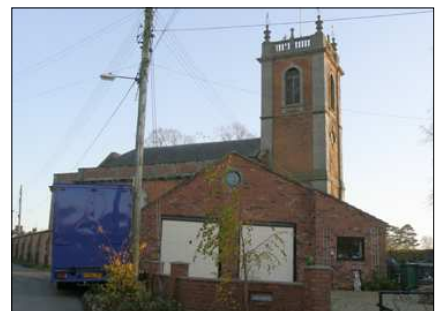
5.6 Views of St Deniol's Church on the approach into the village from Church Road are greatly obstructed by the double garage situated within the grounds of the neighbouring property.

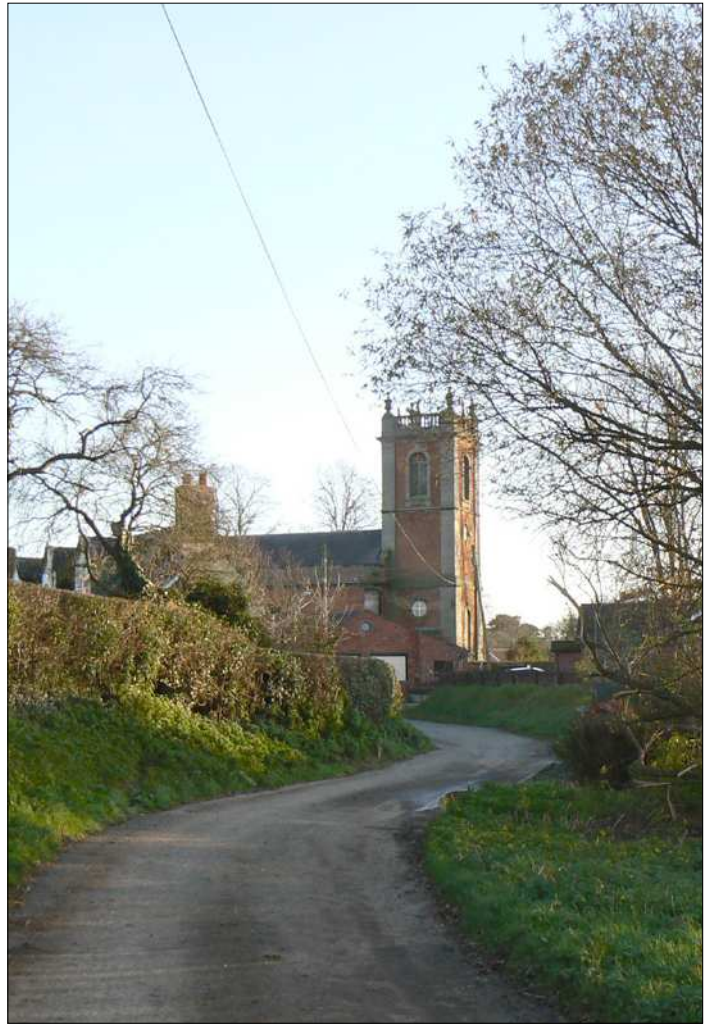
5.7 This is prevalent throughout the Conservation Area and particularly concentrated within the village centre sub-area and has a significantly negative impact upon the appearance of the area.

ENHANCEMENT PROPOSALS	RESPONSIBLE BODY
Overhead Wiring - Extensive overhead wiring at the centre of the village, has a significant detrimental impact upon the appearance of the area and would be better relocated underground.	Utilities Company - Manweb
